WaveSculptor Software & Firmware Changes

TRI50.038 ver5
13 November 2008

The purpose of this document is to detail the differences between firmware versions TRI50v3.13 to TRI50v3.31. The differences between the WaveSculptor controls and configuration software version 2.07 to 3.05 are also described.

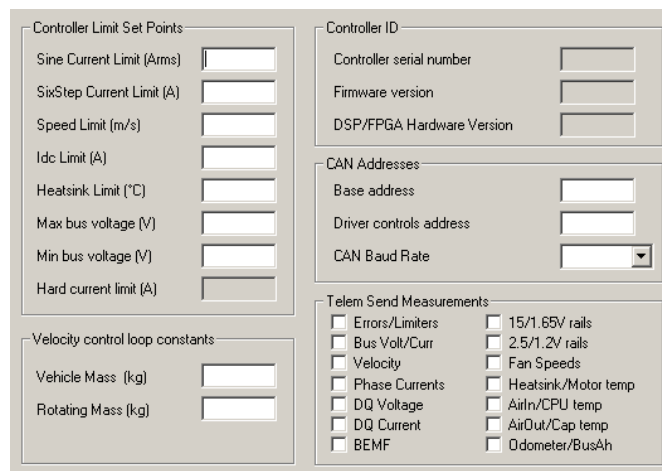
Version 2.07 of the WaveSculptor controls and configuration program has been updated to version 2.09. Version 2.09 is compatible with the new configuration version 1.01. In version 2.09, the current limit setting has been split into two, the Sine Current Limit (Arms) and the SixStep Current Limit (A), shown in the top left corner of Illustration 1. There has also been an extra setting for the software over-current set point added to the calibration screen, which should read 165A.

The screenshot shows a configuration dialog box with several sections:

- Controller Limit Set Points:** Includes input fields for Sine Current Limit (Arms), SixStep Current Limit (A), Speed Limit (m/s), Idc Limit (A), Heatsink Limit (°C), Max bus voltage (V), Min bus voltage (V), and Hard current limit (A).
- Controller ID:** Includes input fields for Controller serial number, Firmware version, and DSP/FPGA Hardware Version.
- CAN Addresses:** Includes input fields for Base address and Driver controls address, and a dropdown menu for CAN Baud Rate.
- Velocity control loop constants:** Includes input fields for Vehicle Mass (kg) and Rotating Mass (kg).
- Telem Send Measurements:** A grid of checkboxes for: Errors/Limiters, Bus Volt/Curr, Velocity, Phase Currents, DQ Voltage, DQ Current, BEMF, 15/1.65V rails, 2.5/1.2V rails, Fan Speeds, Heatsink/Motor temp, AirIn/CPU temp, AirOut/Cap temp, and Odometer/BusAh.
